# MALSEMUSCHEL 2017

**VÝZKUMNÝ ÚSTAV  
VODOHOSPODÁŘSKÝ  
T.G. MASARYKA**  
veřejná výzkumná instituce

# Malsemuschel field activities (Czech side)

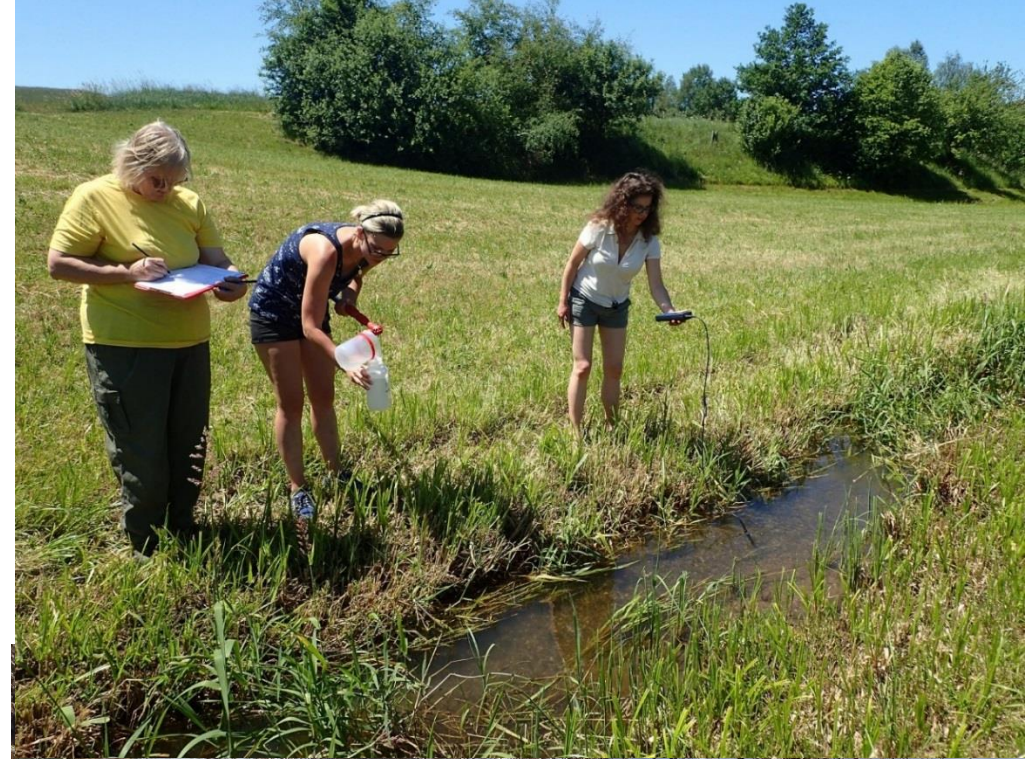
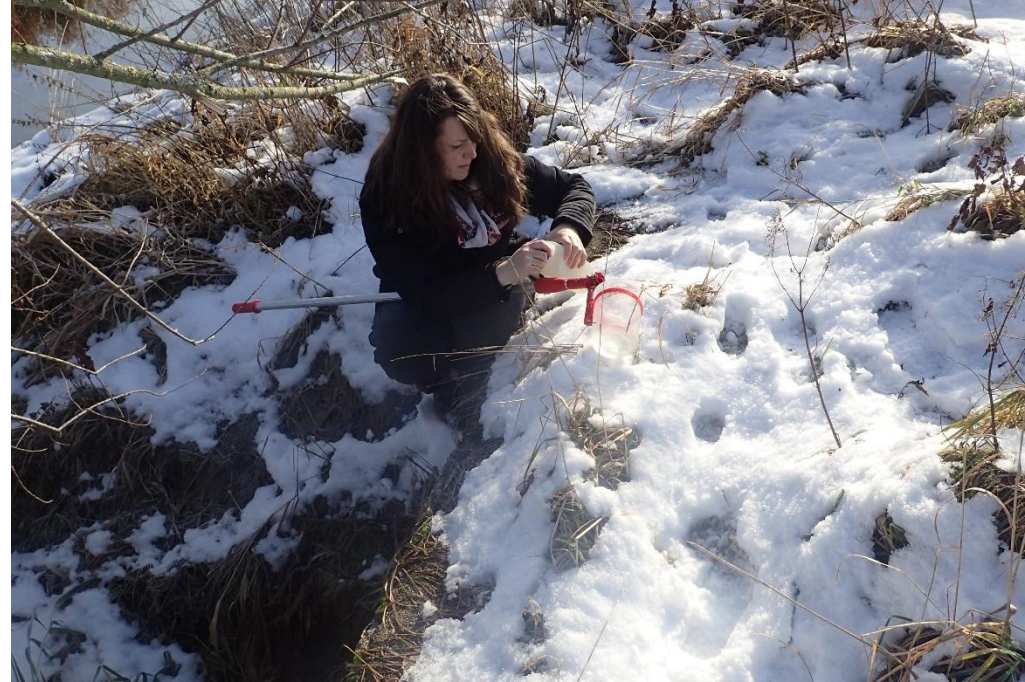
# Water chemistry monitoring - the knowledge of the chemical parameters is essential prerequisite for subsequent management

- regular monthly monitoring on 26 locations
- measurement on site: conductivity, temperature, pH
- measurement in lab:  $\text{NH}_4^+$ ,  $\text{NO}_2^-$ ,  $\text{NO}_3^-$ , Pcelk,  $\text{PO}_4^{3-}$ , Ca, NL;
- randomly:  $\text{O}_2$ , CHSKCr, BSK5, KNK,  $\text{Cl}^-$ , Mg, Fe, Mn and other metals (Al, Ni, As, Be, Cd, Cu, Pb, Zn, Hg)

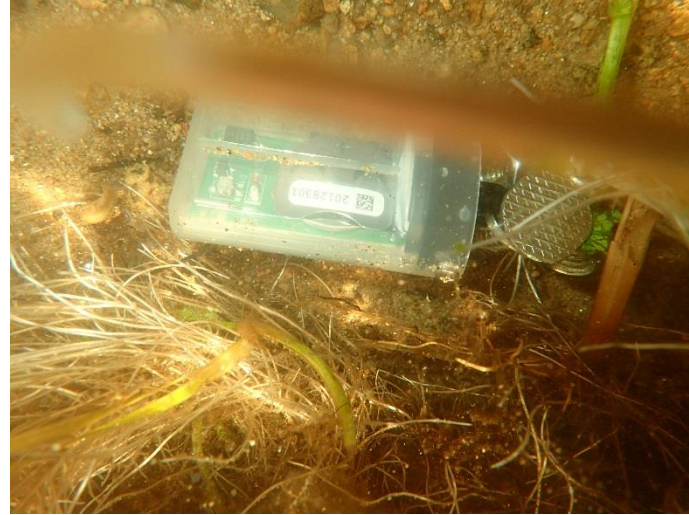
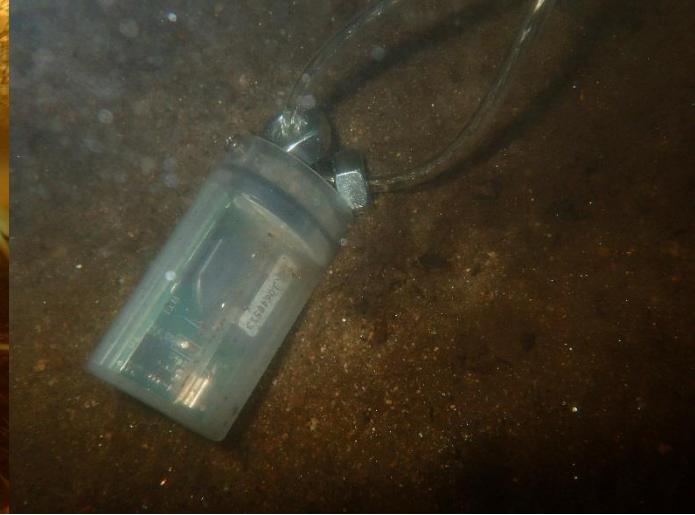
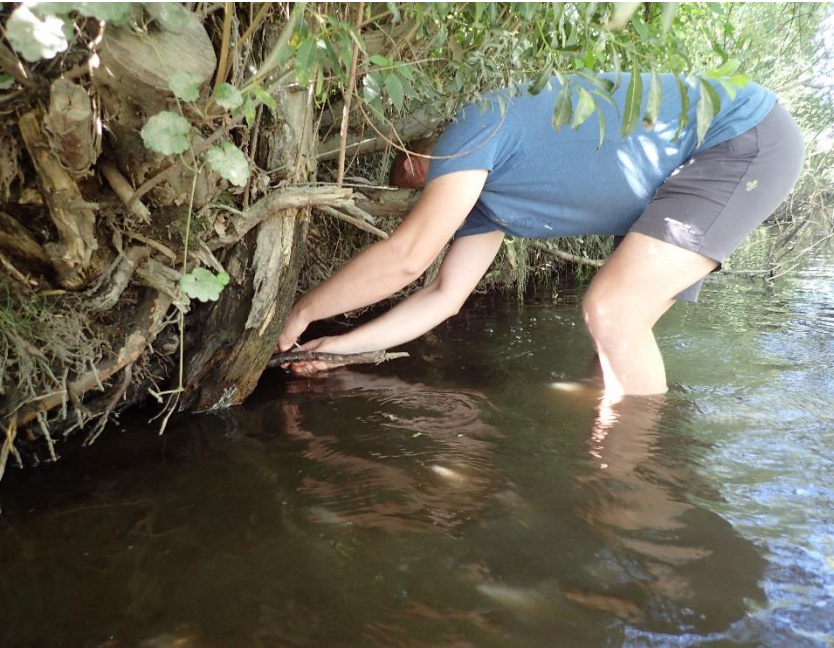
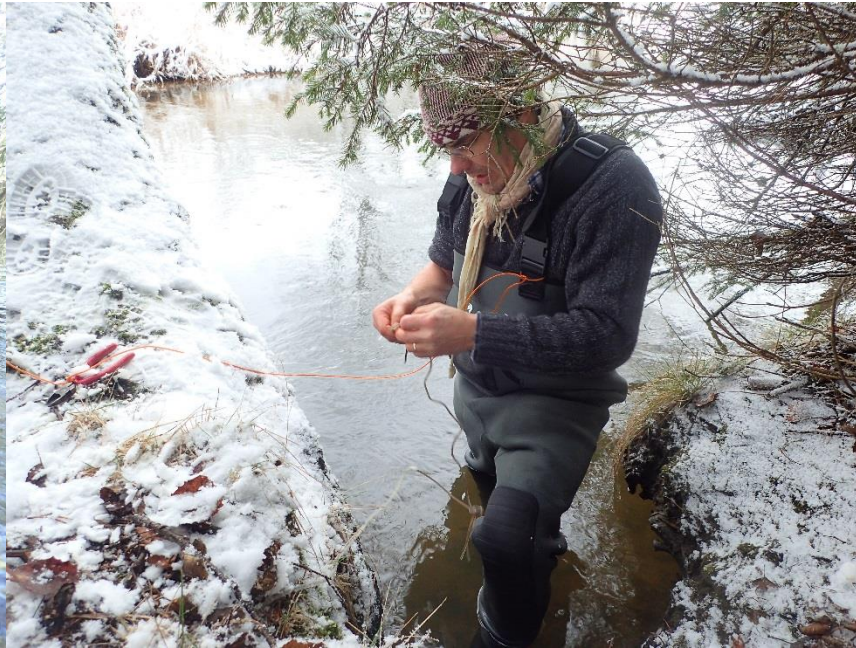
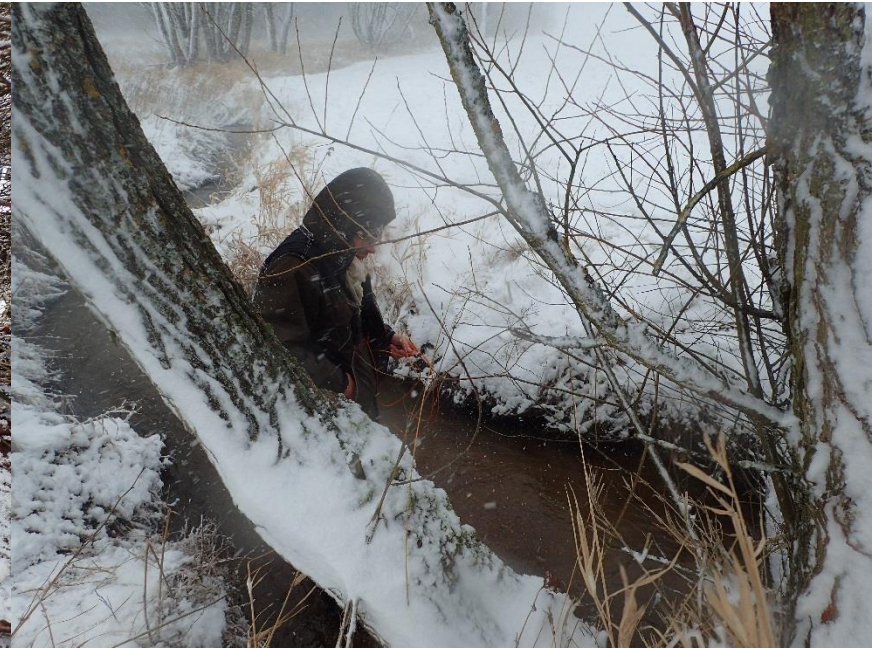
# Temperatures probes HOBO – obtaining of continuous temperature datas → important for capture of unpredictable events

- the location the same as for chemistry monitoring
- hourly records of temperature and lighting
- from August 2017 in the flow
- control and exchange in January 2018

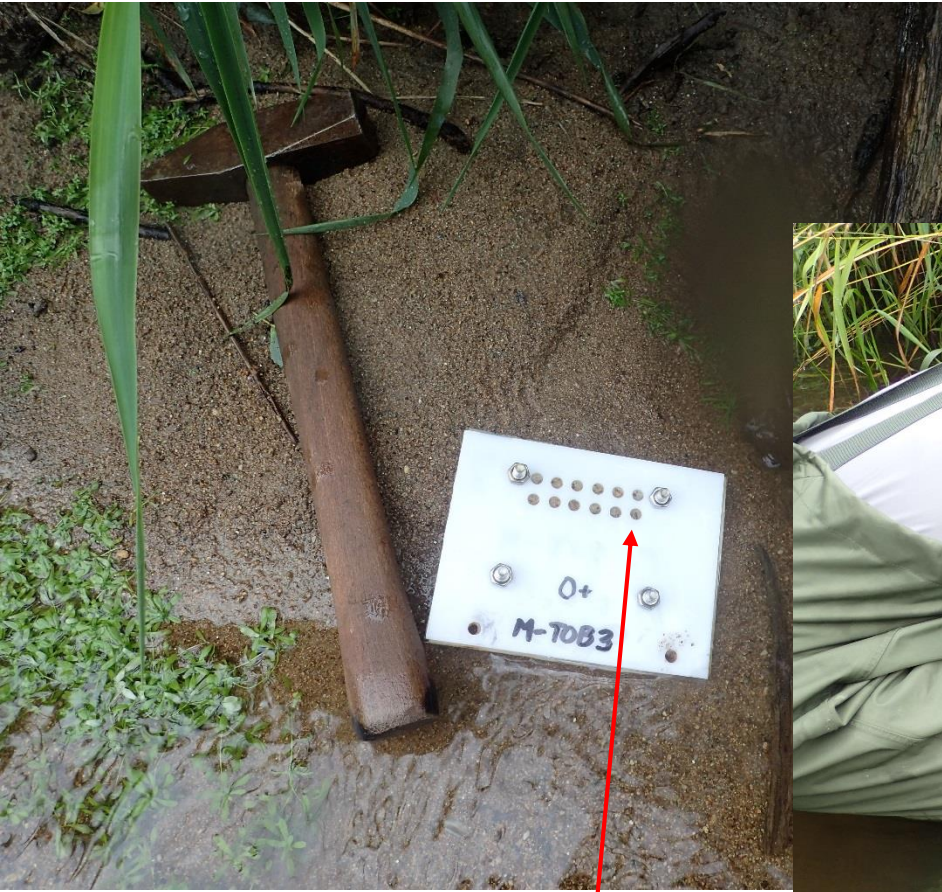
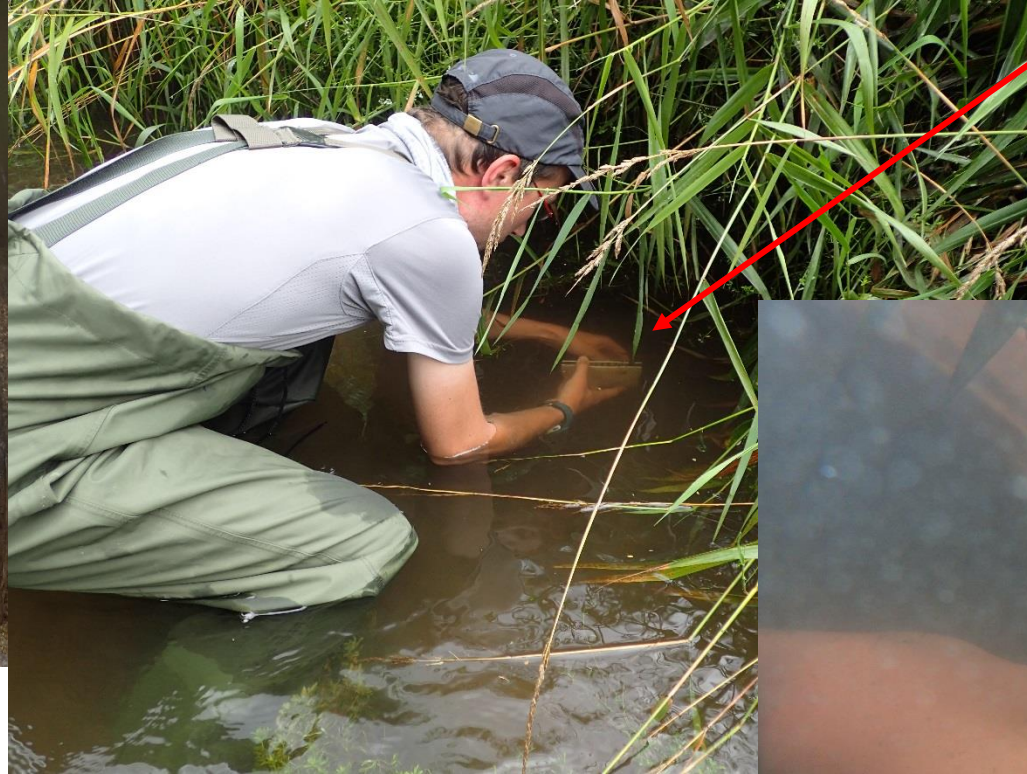
the bioindication plates are placed in the flow

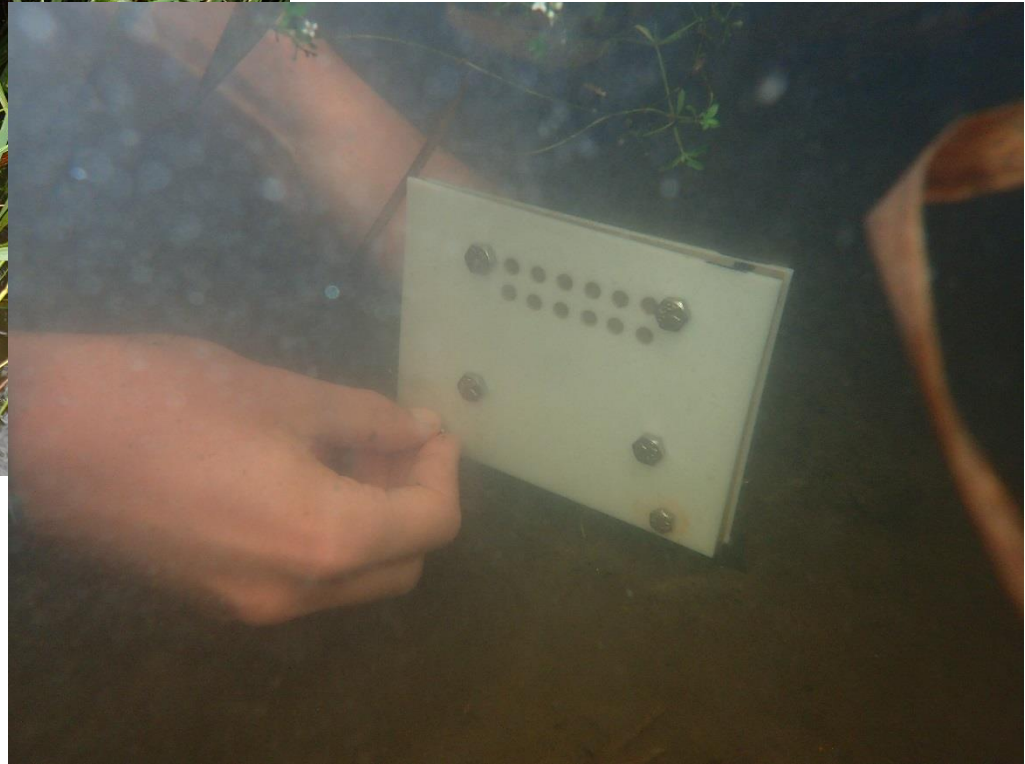
the bioindication plates are fixed in the river (each site 4 plates with 0+ and 4 plates with 1+)

in each hole there is 1 pcs of *Margaritifera* in age 0+ / 1+ MM („Buddensieck“)

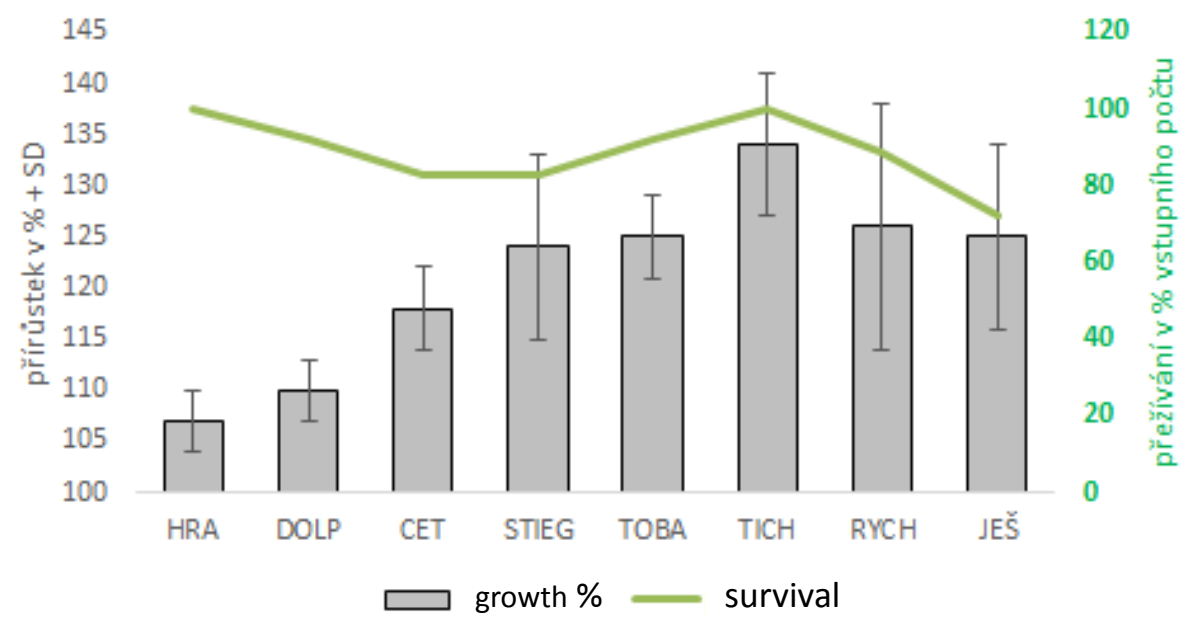
Malše 2017 srpen, přírůstky a úmrtnost juvenilů 0+ (FŽP ČZÚ, Švanyga, Simon a kol.) N=24, expozice 30 dnů

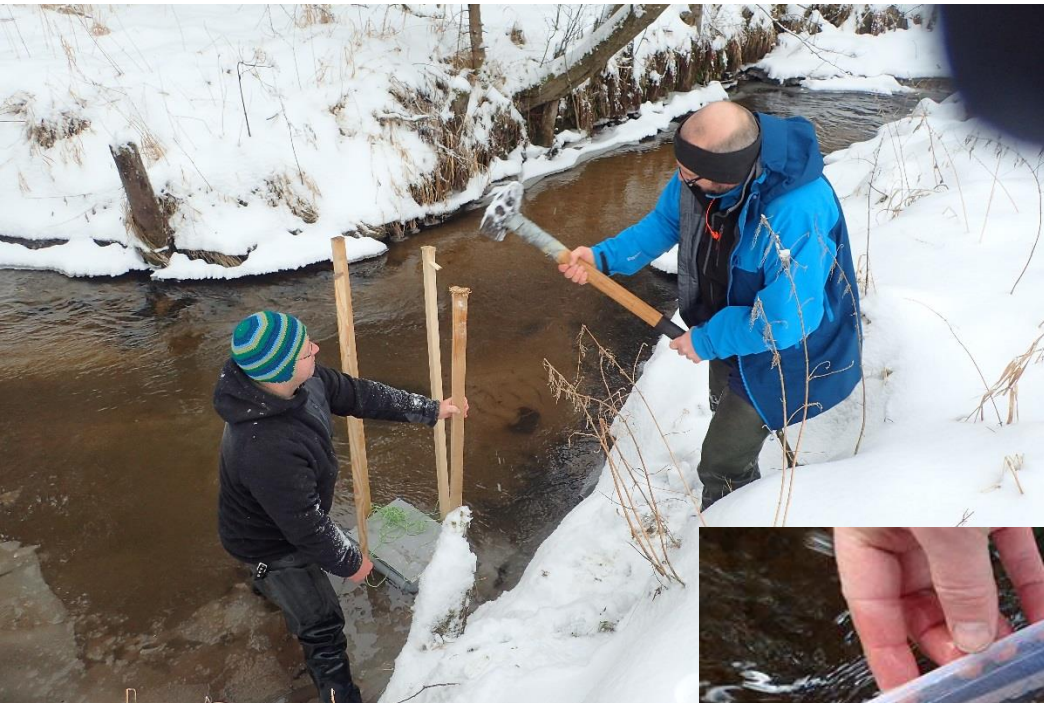
# Firzlaff's apparatus (apparatus for fry hatching)

→ support of population of *Salmo trutta*.

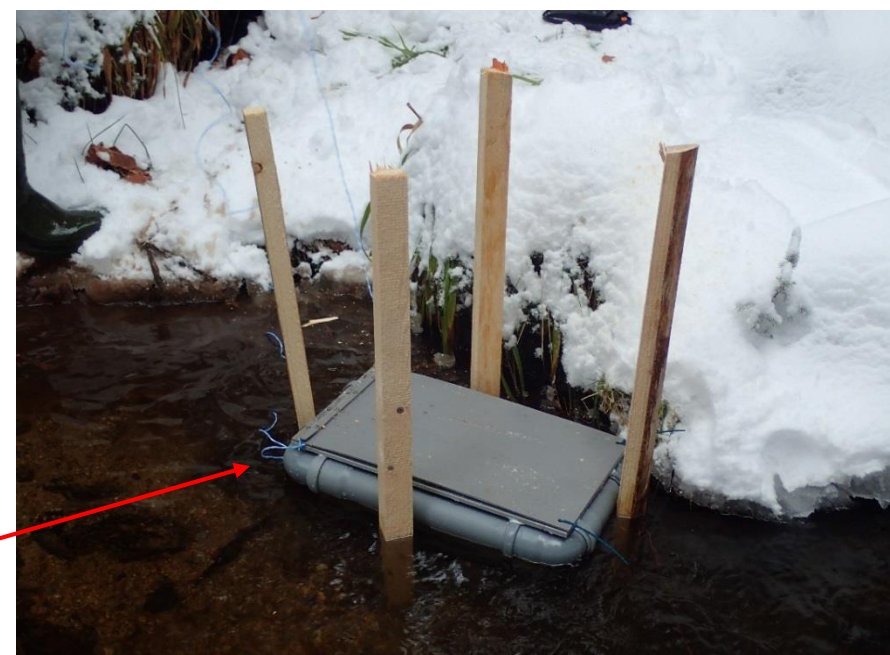
- location in Maltsh and tributary
- placed 18 apparatus

protected against the predators
